## Worker Fatality Alert

### Methylene chloride linked to worker death in church

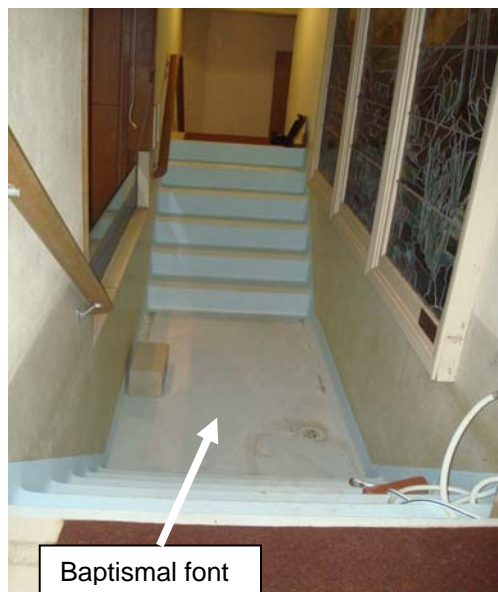
**What happened?** The victim was removing a waterproof paint coating from the baptismal font (tub) of a church. The font is located in a narrow, enclosed room (41 feet long by 4 feet wide by 12 feet high) and bordered by two sets of steps. There are two doors on each end of the room and a large window facing the congregation. The victim applied one gallon of a paint stripper containing 60 – 85% methylene chloride to the steps and font. The paint stripper is a widely available consumer product and was purchased by church staff at a local home improvement store. There was a small portable fan close to the work area and the victim did not use respiratory protection. The victim probably did not know how quickly he could be overcome by the methylene chloride vapors in a closed room. The church pastor saw the victim working in the late afternoon. At that time the doors and window were open and the paint stripper had been applied to the font surface and steps. Later that night, however, another church staff person found the victim motionless on the floor of the font with the doors and window closed. He was pronounced dead by emergency medical personnel.

**What was the cause?** The victim died from inhaling toxic amounts of methylene chloride in a small, poorly ventilated space. Methylene chloride vapor can build up in air quickly and can be fatal if too much is inhaled. Between 2000 and 2011, methylene chloride-based paint strippers have been linked to 13 deaths of workers refinishing bathtubs. Because methylene chloride-based paint strippers are widely available at local home improvement stores, employers and consumers can easily purchase this potentially toxic product.

**What should be done to prevent this from happening again?** Employers and employees should recognize that methylene chloride can quickly build to toxic levels in poorly ventilated spaces. Warning labels are often not adequate to guide safe work practices in these spaces. Precautions should include an air-supplied respirator, special protective gloves, and adequate mechanical ventilation. Because of the serious harm that can occur from inhaling methylene chloride vapors, employers, workers, and consumers should always consider safer alternatives to strip paint from surfaces. Abrasive sanding with local exhaust ventilation to capture dust, or benzyl alcohol based strippers (without n-methyl pyrrolidone or NMP) can be used with good results. These safer strippers can be found at select local stores.
